# Technical Article 1

## Application of FTIR Structural Analysis for Dried Coating Failure Investigation in Oil & Gas Industry

<sup>3</sup>PETRONAS Group Technical Solutions, 50050 Kuala Lumpur, Malaysia  
E-mail: zaid\_kamardin@petronas.com, muhammadafiq.mansor@petronas.com

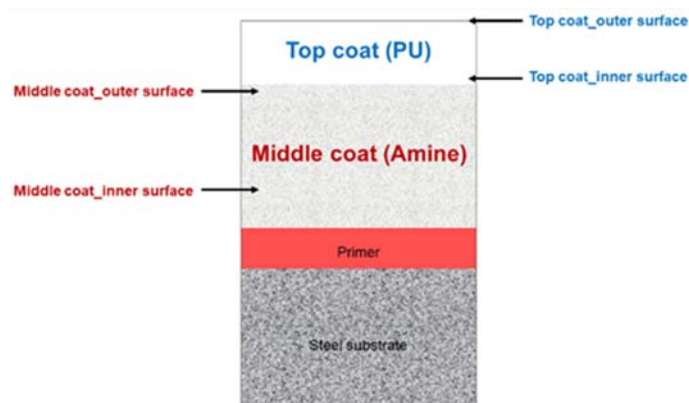
The failed three-coat system consists of PU and amine-based paints which serve as the top coat and middle coat, respectively, of the refinery tanks located in a hot and high humidity environment. The schematic diagram of the coating system is shown in **Figure 1**. The middle coat is the dried and cured amine-based 2-pack paints used as passive fire protection (PFP) of the tanks. From the materials safety data sheet (MSDS), part A and part B of these 2-pack paints mainly comprise a mixture of organic-inorganic components (isocyanate-based components) for part A as the base; and amine-based components for part B (moisture sensitive amine as the hardener). Meanwhile, PU coating is dried and cured 2-pack paints that consist of polyol-based components (part A) and isocyanate-based components (part B as the hardener).

**Figure 1:** Schematic diagram of the dried coating system applied on a refinery tank.

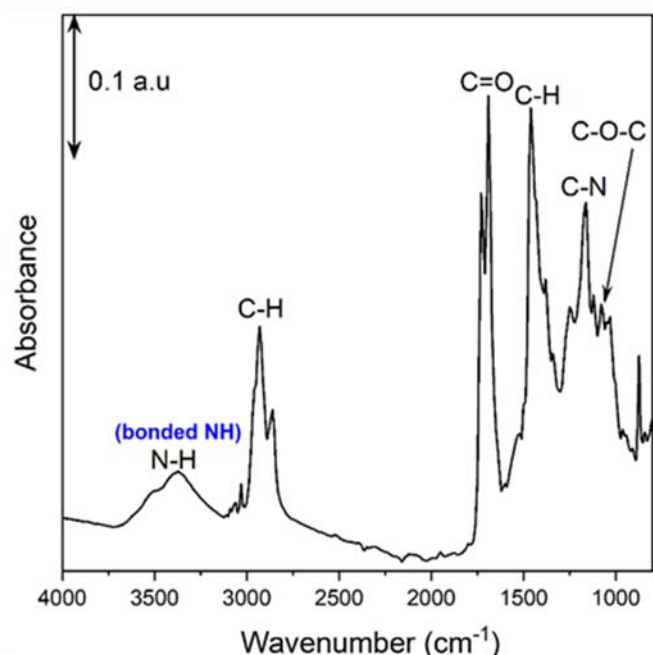
**Topcoat\_Fresh\_outer surface** (PU coating) displays a typical FTIR spectrum (*c.f.* **Figure 2**) and all absorbance bands are consistent with references [6, 7]. The disappearance of the isocyanate absorbance band around 2250  $\text{cm}^{-1}$  in the spectrum indicates that all isocyanates have been reacted with the polyol-based component in the curing reaction. The **bonded NH** band observed at ~3300  $\text{cm}^{-1}$  is assigned to the N-H stretching in PU as illustrated in a chemical equation in **Figure 3**.

**Figure 2:** FTIR spectrum of **Top coat\_Fresh\_outer surface** (PU coating).

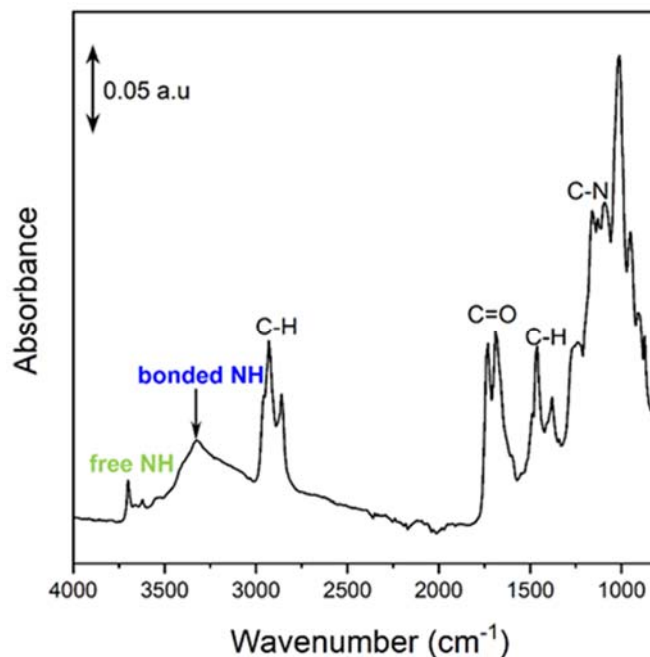
The FTIR spectrum for the **Middle coat\_Old\_outer surface** is shown in **Figure 4**. It presents the typical functional groups in polyurea [8], except for the **free NH** functional group observed at  $\sim 3600 \text{ cm}^{-1}$ . The presence

of **free NH** implies the excess amount of amine-based components in Part B which are not fully reacted during the curing process. The ‘complete’ and ‘incomplete’ reaction in the 2-pack coating of the middle coat is suggested in **Figure 5**. The **bonded NH** displayed in the spectra is assigned to the amide functional group present in polyurea.

**Figure 4:** FTIR spectrum of **Middle coat\_Old\_outer surface**.

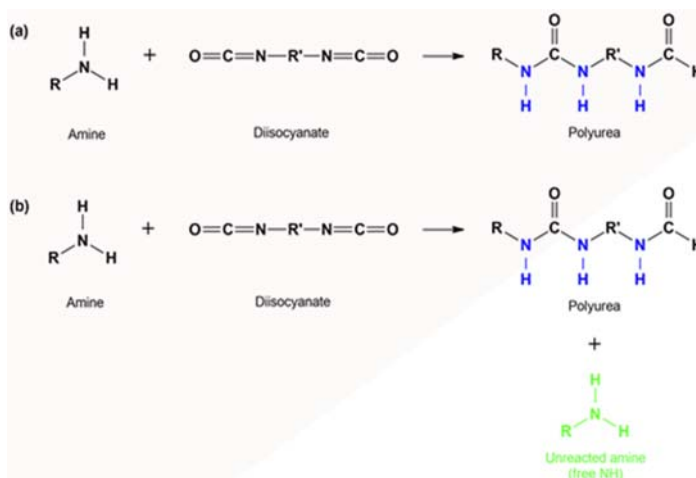
**Figure 5:** The schematic chemical reaction of (a) complete reaction and (b) incomplete reaction of amine and isocyanate to form polyurea. Note: the chemical equations are not balanced and for illustration purposes.

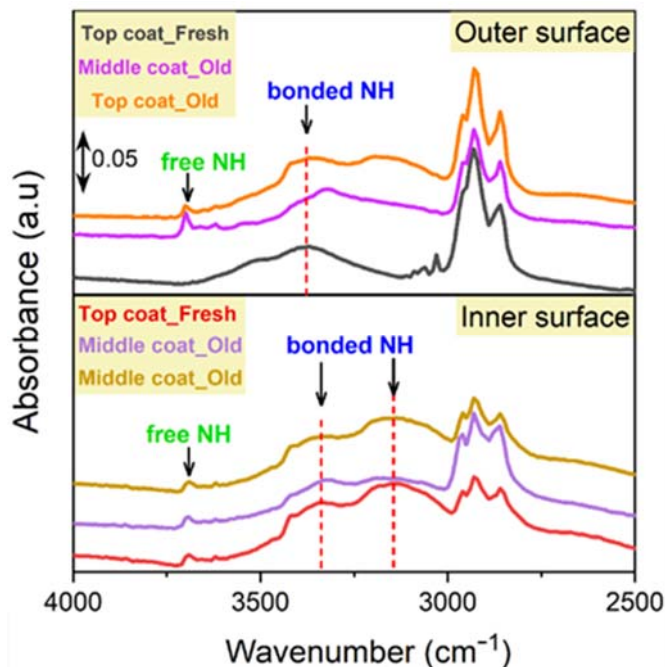
The FTIR spectra for all samples are shown in **Figure 6**. Comparison between the fresh and old samples through visual inspection is highlighted here. As shown, the **Top coat\_Old** sample displays the **free NH** absorbance band which indicates the presence of a **free NH** functional group on the top coat after eight months of application. It is suggested that the **free NH** observed in the **Top coat\_Old\_outer surface** is very likely originated from the middle coat. The excess amount of amine-based components described earlier may have migrated to the topcoat after some time. The hot and high humidity environment has drawn up these amine-based components from the middle coat to the topcoat and causes the top surface to be sticky.

Figure 6: FTIR spectra of the topcoat and middle coat.

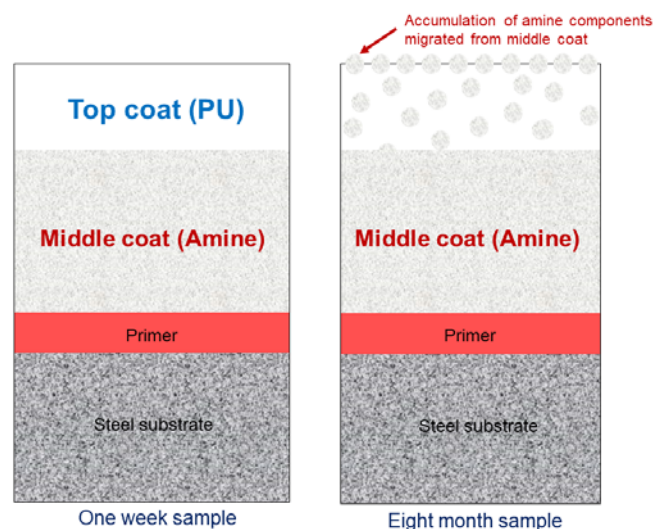
A lower degree of similarity between **Middle coat\_Old** and **Topcoat\_Fresh** is expected because both coats have different chemical components as indicated in their materials safety data sheets. However, the difference of **Topcoat\_Old** from **Topcoat\_Fresh** might be owing to the appearance of **free NH** group and significant shifting of the **bonded NH** group to lower wavenumber as can be observed in the FTIR spectra of **Topcoat\_Old** after 8-month of application (see **Figure 6** for the differences). These occurrences may indicate the chemical structure of the topcoat as well as its composition changes after a certain time.

Figure 7: Comparison of the fresh (one week) and the old (eight months) samples.

Failure analyses 1 and 2 demonstrate that the **Topcoat\_Old** sample has different components and compositions as compared to the **Topcoat\_Fresh** sample. This is due to the amine component that is present on the surface of the **Topcoat\_Old** after eight months of application. This amine component is very likely originated from the middle coat, which is in agreement with the  $r$  value as listed in Table 2. The **free NH** may have migrated from the middle coat to the surface of the topcoat after eight months of application as illustrated in **Figure 7**. Hence, the repair works is suggested to be targeted not only to the topcoat but also to the middle coat of the coating system. Furthermore, this analysis has shown that the FTIR technique is practical as it provides a quick evaluation test, reliable results, economical and does not need any sample preparation. The utilization of IMMFP03 in this work has demonstrated its practicability and feasibility to be used in coating failure analysis.
